# LD Wayside Ultrasonic Inspection System for Wheels

# 1. General Introduction

LD Wayside Ultrasonic Inspection System(hereinafter referred to as LD system) is for defects detecting in wheel rim.

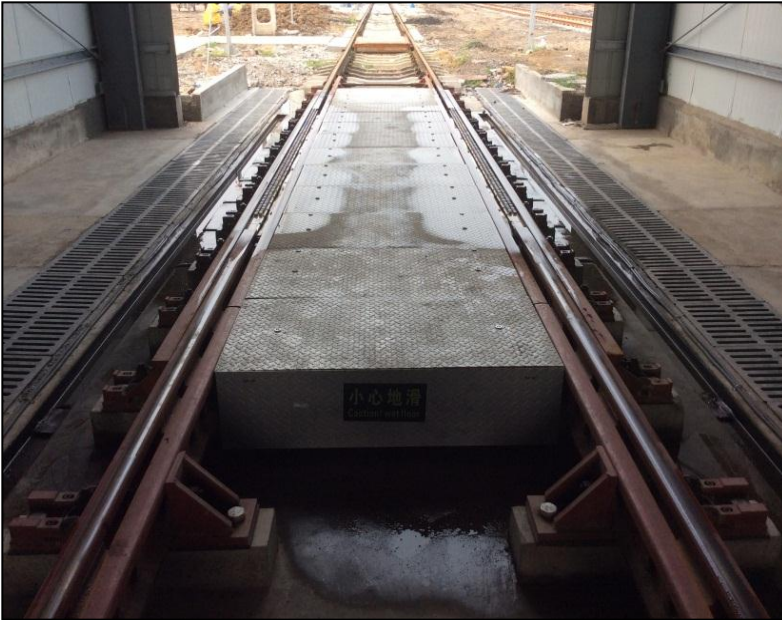
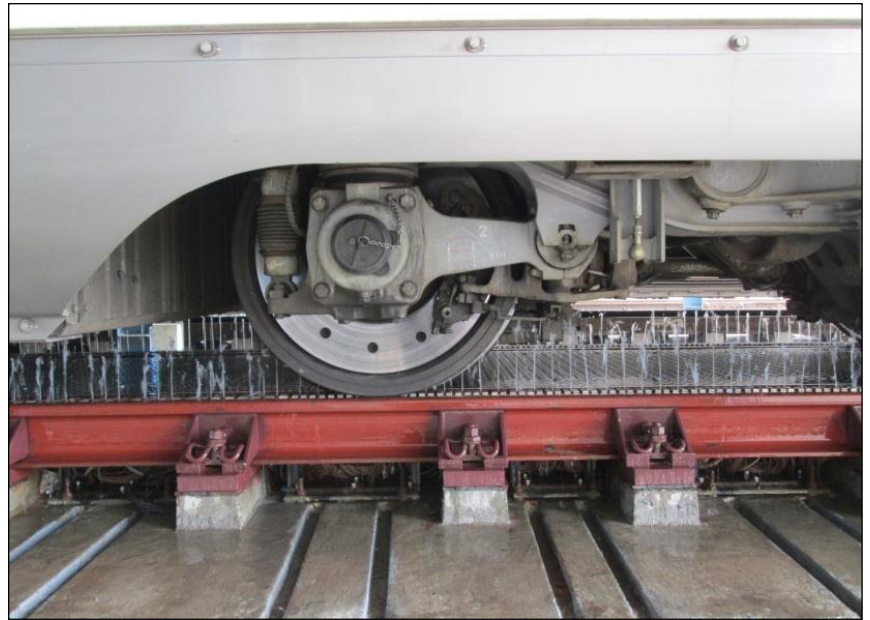
- ✓ Longitudinal wave probe(TR probe) for circumferential defects
- ✓ Transverse wave probe(AP probe) for radial defect in wheel rim and flange

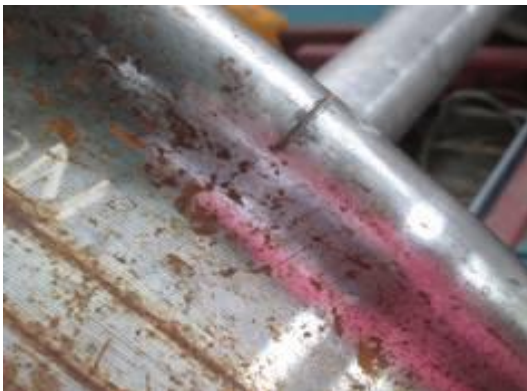
- 5mm depth radial notch at the top of wheel flange (AP probes)

Wheel flange

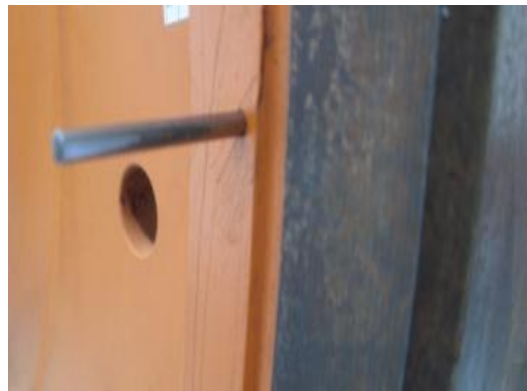
- $\Phi 3 \times 100$  mm SDH(side drilled hole) (AP probes)
- Circumferential defect in flat bottom ellipse with 50mm long axis, 30mm minor axis at 60mm ~100mm regions (TR probes)

Radial defects of wheel rim

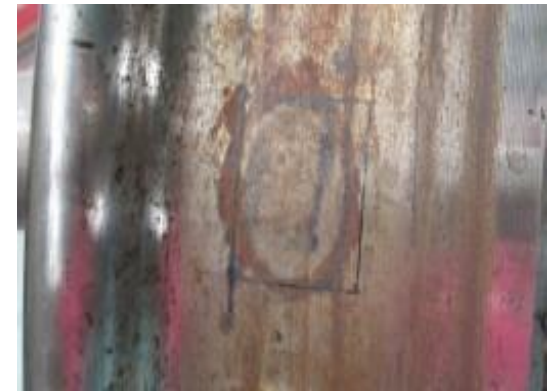
Circumference defects of wheel rim

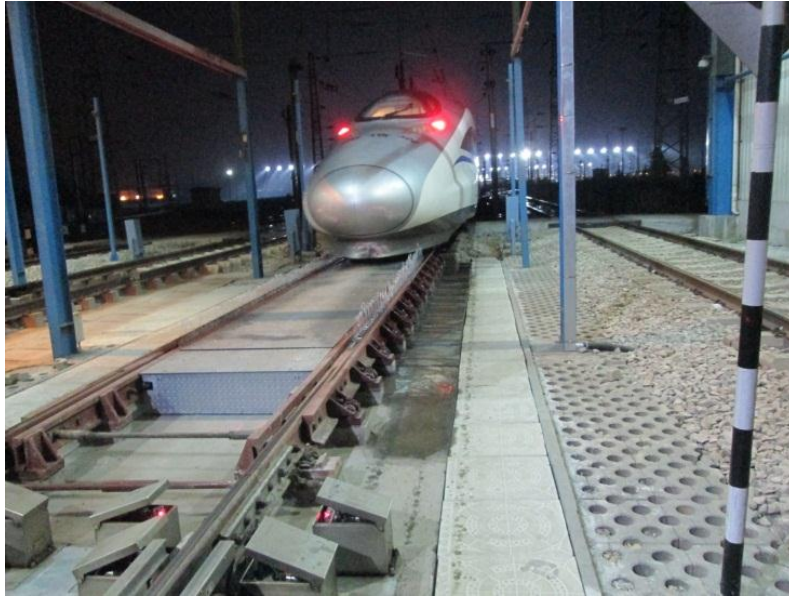
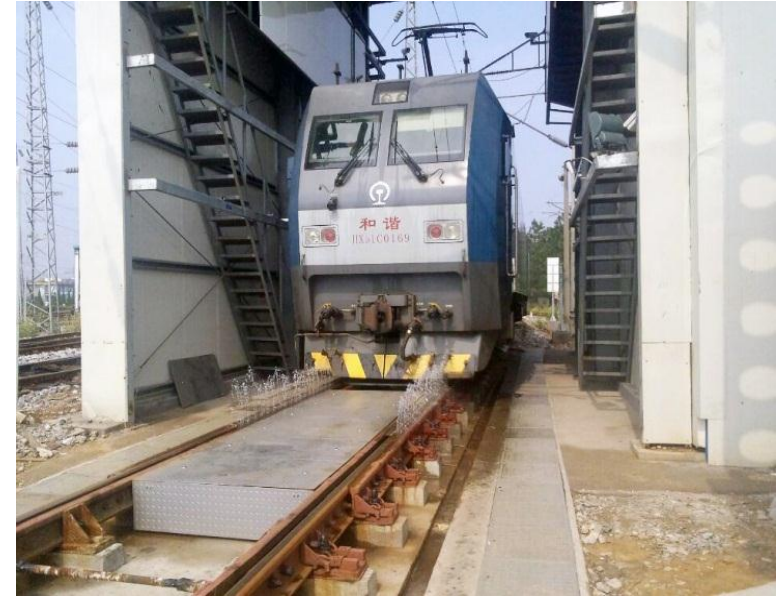
- Probe frequency: 2.5MHz
- Inspection speed:  $\leq 20\text{km/h}$ ;
- constant speed is recommended.
- Axle loading:  $\leq 30\text{t}$

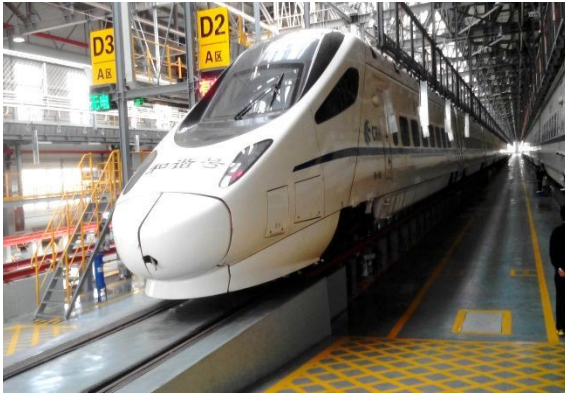
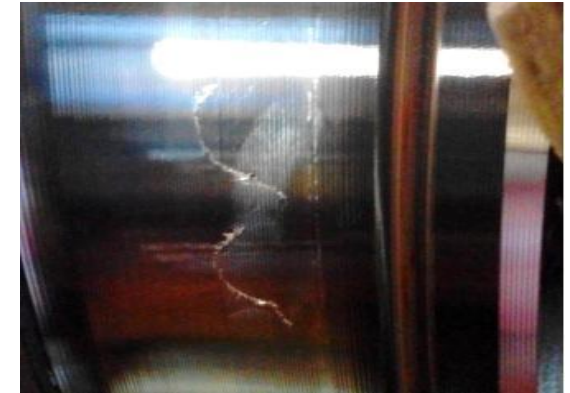
Crack with 70mm length and 17mm width, 10mm below the wheel rim tread

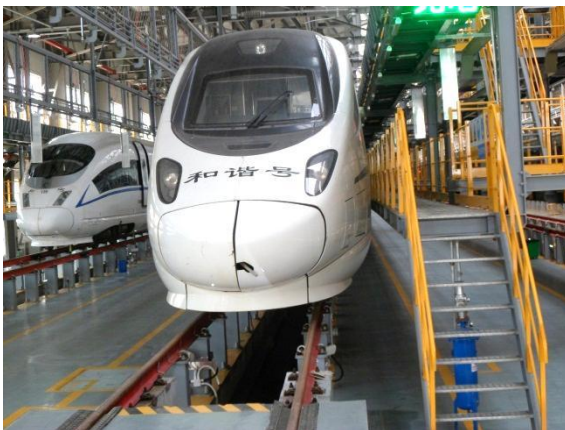
Crack with 25mm length and 30mm width, 5mm below the wheel rim tread

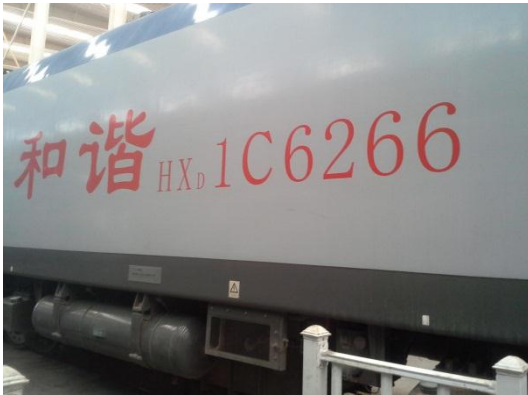
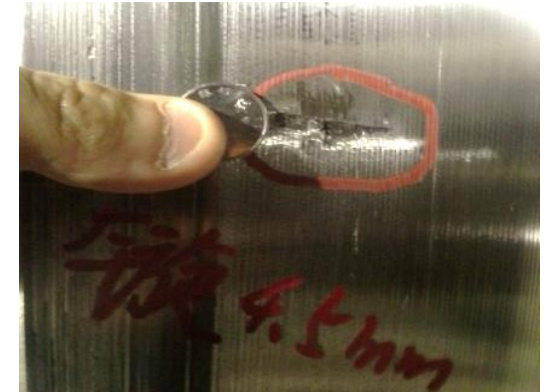
Crack with 5mm length and 30mm width, 8mm below the wheel rim tread

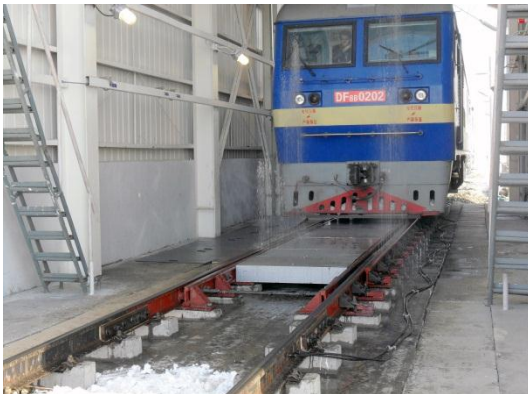
Crack with 77mm length and 2mm width, 11mm below the wheel rim tread

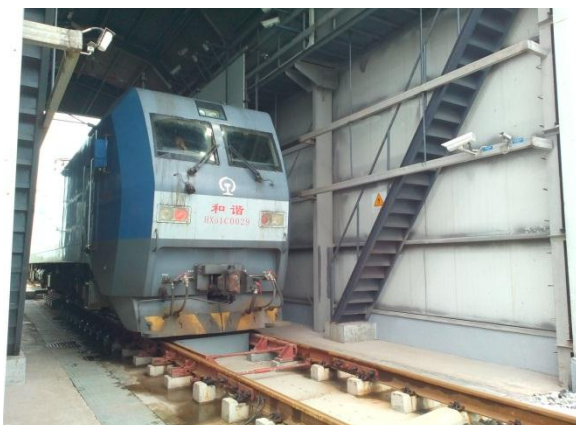
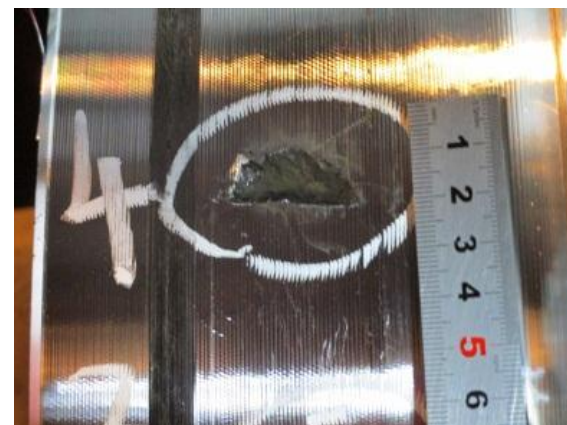
Crack with 10mm length and 30mm width, 10mm below the wheel rim tread

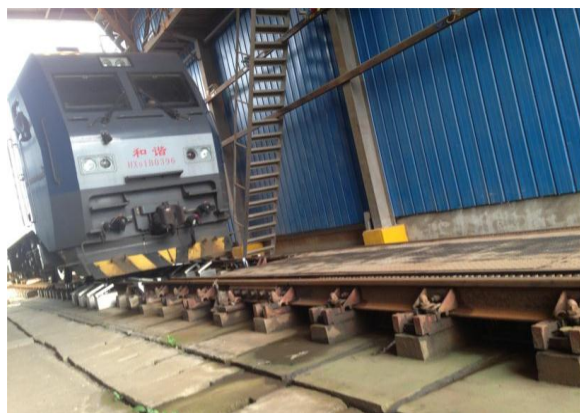
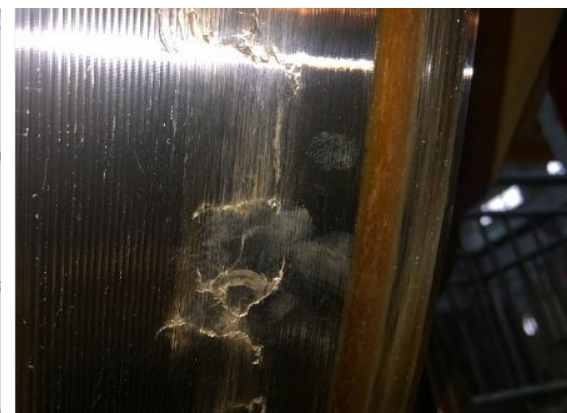
Crack with 80mm length and 25mm width, 11mm below the wheel rim tread
